DLR researchers first to make causes of helicopter noise visible

07 January 2014

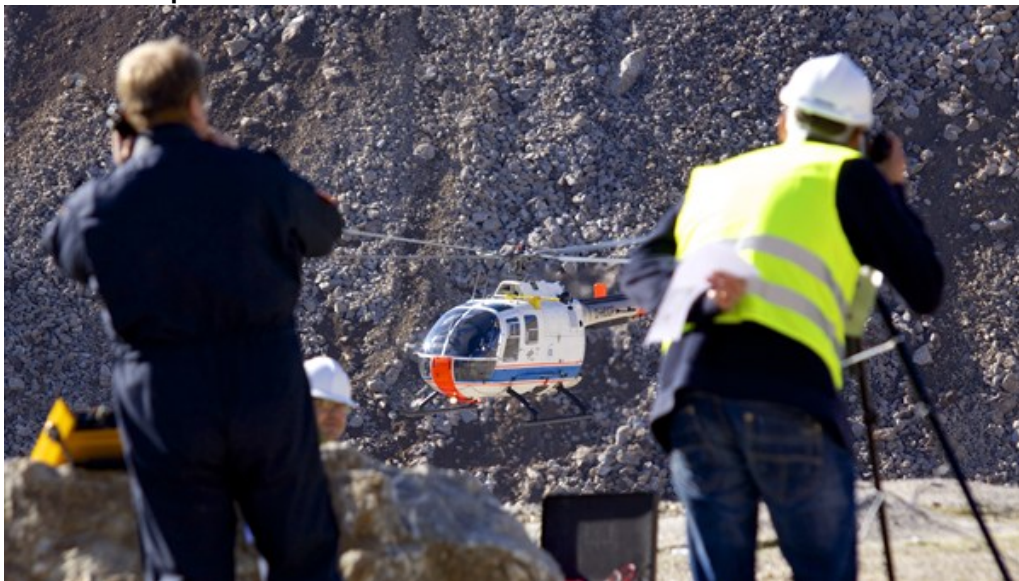
Cameras in operation

Ten cameras recorded the BO 105 helicopter from various angles.

The latest experiment took place just recently; the BO 105 descended into a quarry in the Harz region – a hazardous environment for a helicopter. The confined space and manoeuvres so close to the ground tested the skill of the DLR test pilots. In places, they were asked to perform rocking manoeuvres barely ten metres above the ground while the loose scree littering the excavated rock face served as a backdrop. But the effort was rewarded; ten cameras set up at various angles yielded images of such quality that, for the very first time, a substantial

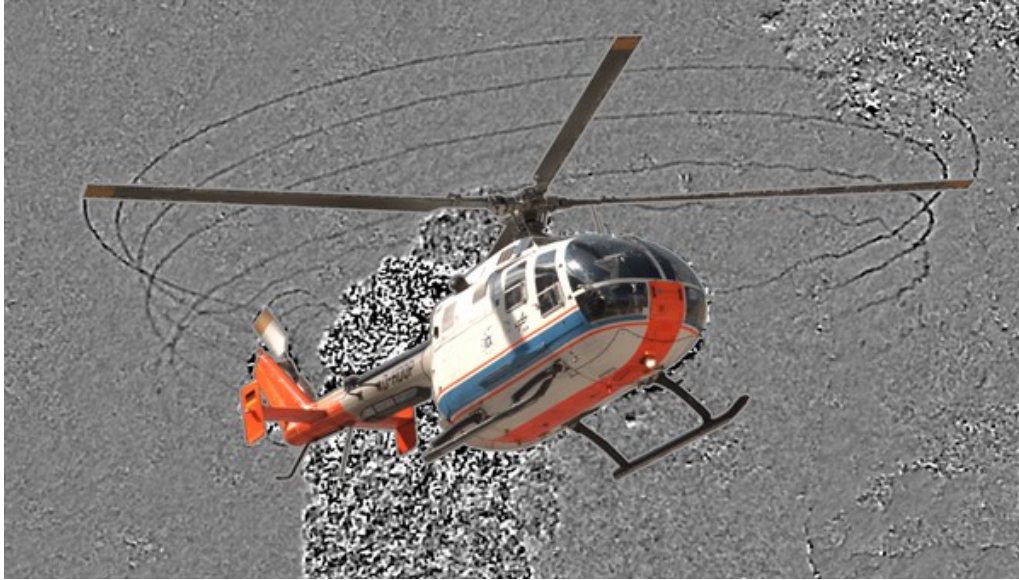
Making the causes of helicopter noise visible

Blade tip vortices are visible as dark lines during a full rotation of the main rotor. The engine exhaust flows are perceptible as a noisy area trailing the helicopter. The tail rotor's vortex system is also visible (black, circular lines on the tail rotor). The helicopter is currently performing a rocking manoeuvre.

As the air flows around the blade tip to reduce the pressure difference, a concentrated vortex is created behind the blade tip. "The noise comes from the vortex behind a rotor blade interacting with the following rotor blade," explains André Bauknecht, leader of the current experiments. These vortices are not just responsible for the typically 'carpet beater' noise; they also produce vibration within the helicopter and make the ride less comfortable for passengers.

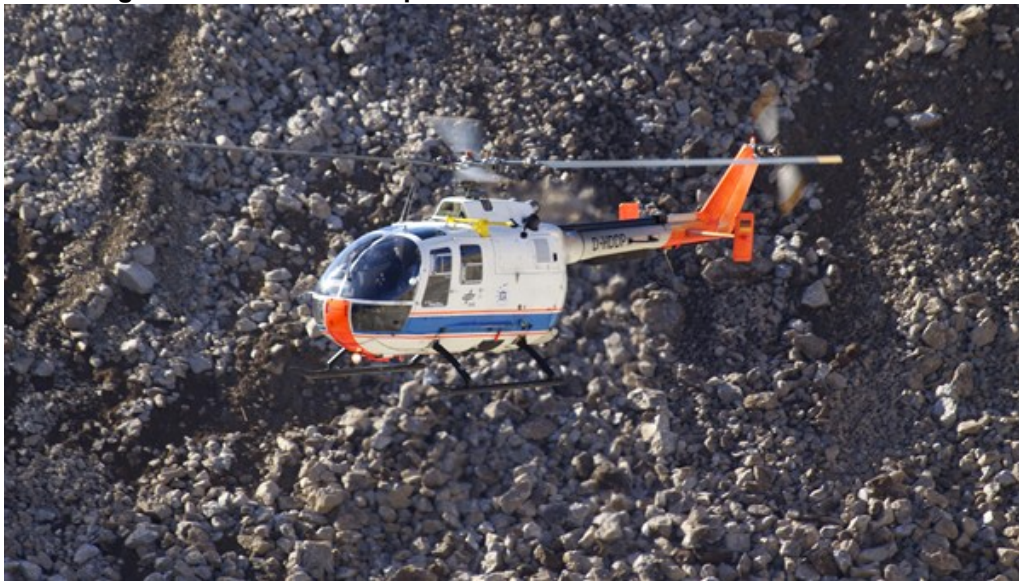
BO 105 against a scree backdrop

The Göttingen-based researchers employed a novel technique to visualise the rotor blade vortices, using the loose scree littering the quarry as a background for their measurement method.

Last year, the DLR scientists conducted a series of unique and at times daring experiments to test the new measurement method in flight. The Göttingen-based researchers employed a novel technique, using natural background areas to visualise the rotor vortices. "A suitable background must be as finely textured and uniform as possible – so we investigated where nature can offer this kind of surface," says Bauknecht.

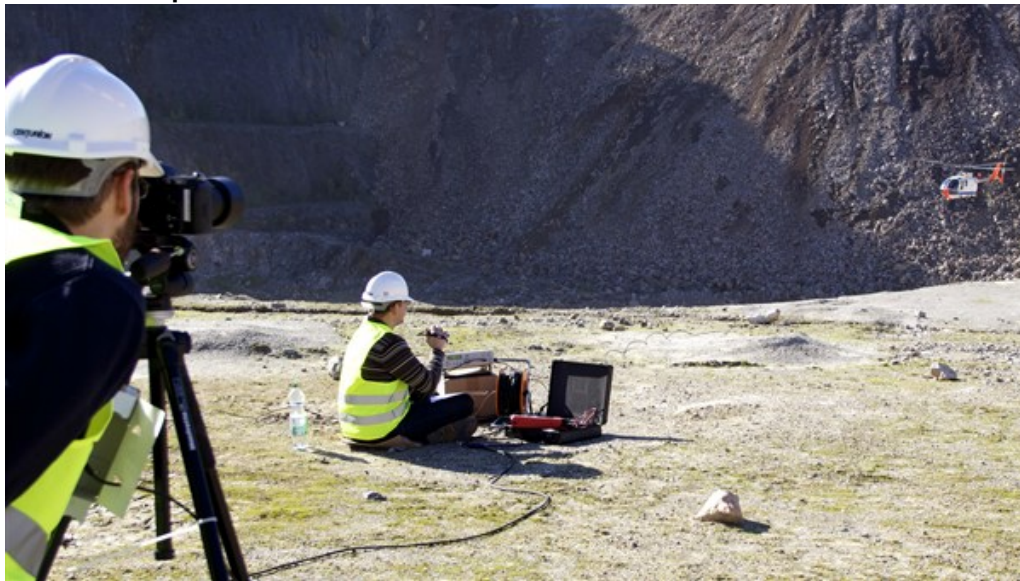
Cameras in operation

Ten cameras recorded the BO 105 helicopter from various angles.

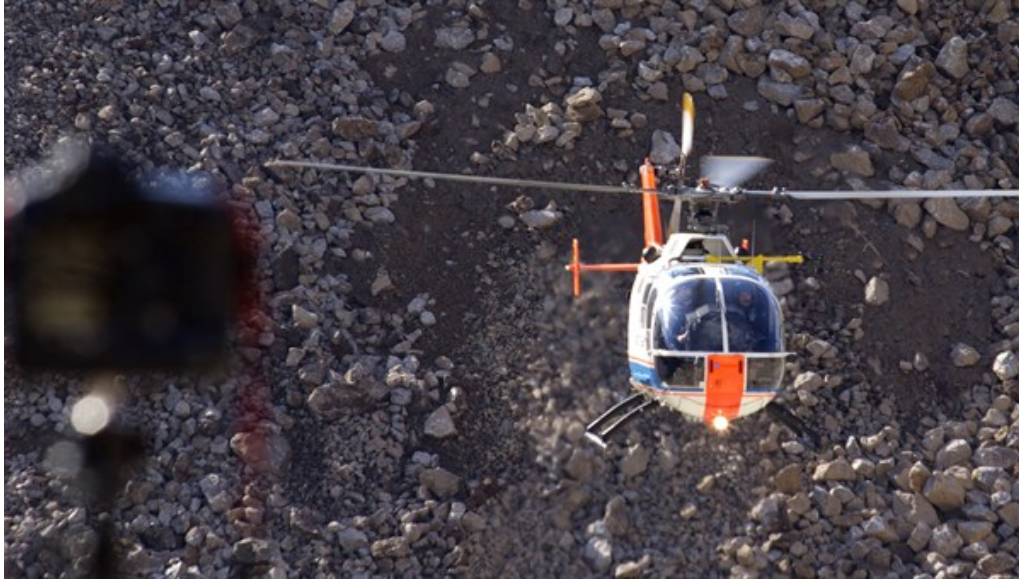
Highest demands on the pilots

The confined space and manoeuvres so close to the ground tested the skill of the DLR test pilots Sebastian Soffner and Uwe Göhmann. In places, they were asked to perform rocking manoeuvres barely ten metres above the ground.

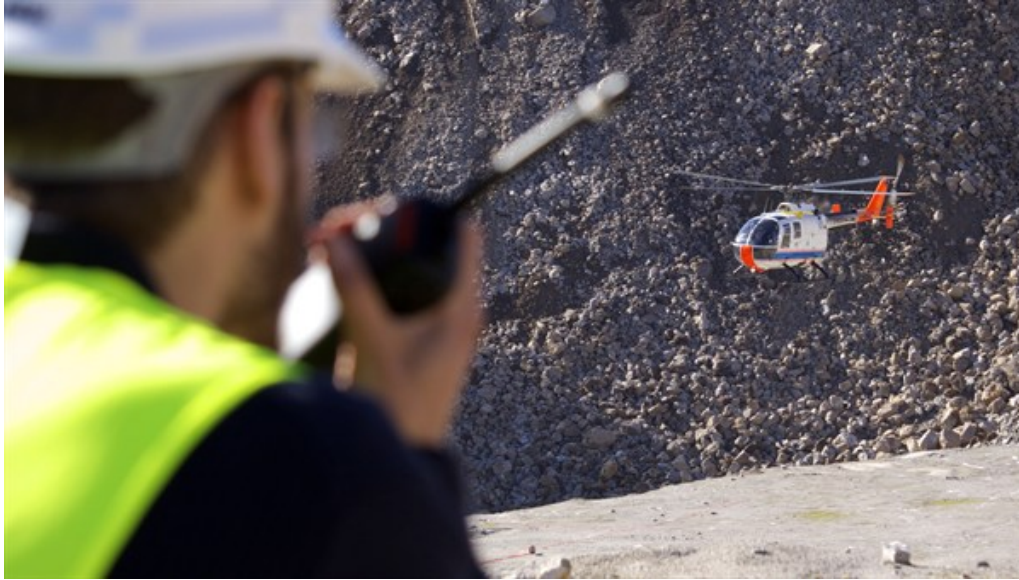
Flying according to precise specifications

Tight coordination between helicopter manoeuvres and camera shots was imperative.
